NOTICE OF VIOLATION # PC 1004-134

Site Inspection Report

Source: ASARCO LLC - Mission Complex

Reason for Inspection: Surveillance during high wind advisory

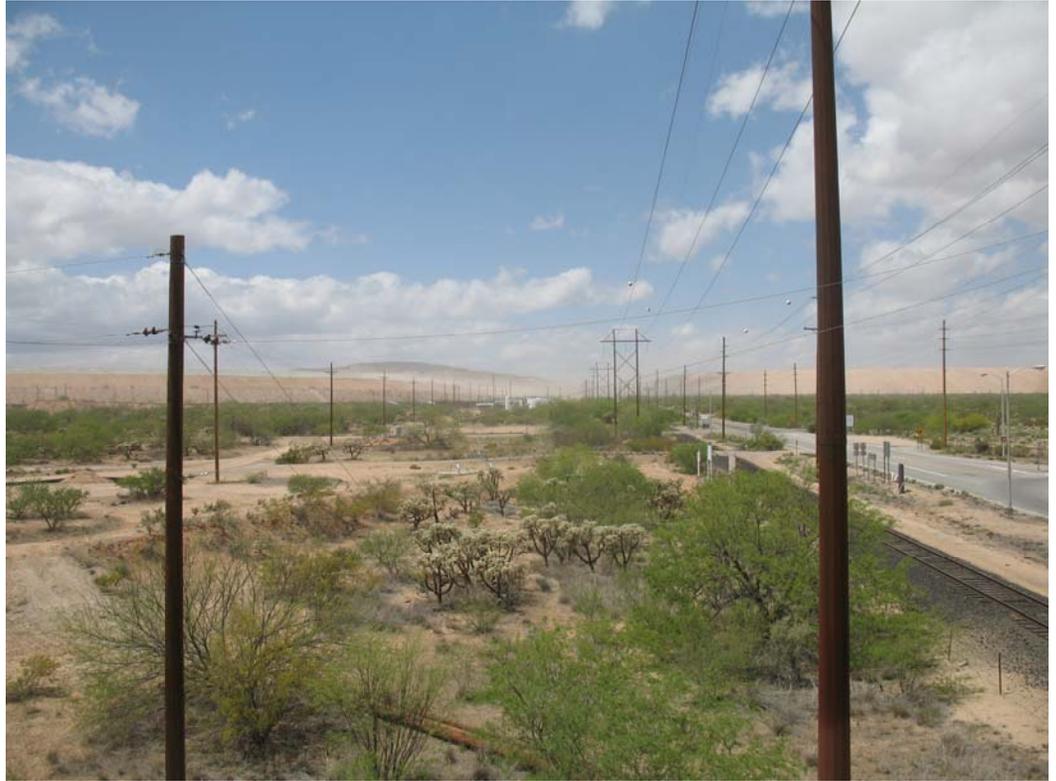
Photo No. 1

View of tailings dam # 4. Fugitive particulate plume was observed over the northeast slope for a duration of approximately 3-6 minutes.

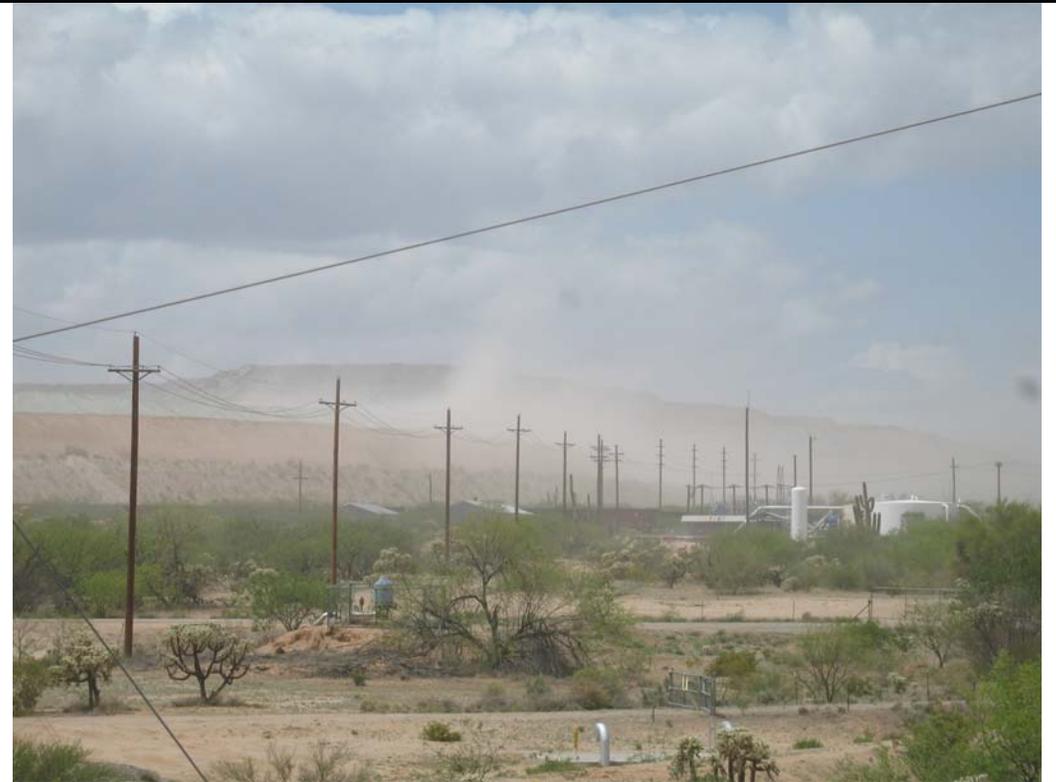
Photo No. 2

View of tailings dam # 4 emission plume.

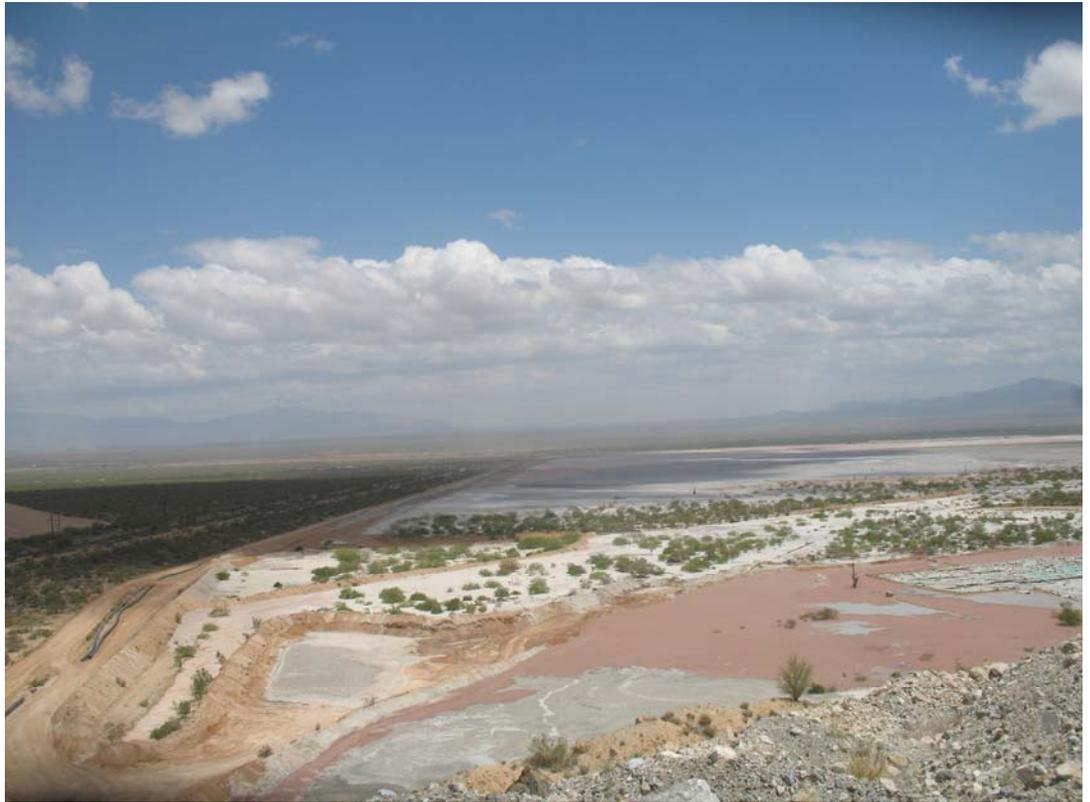
Photo No. 5

View of the tailings dam from the mine area to the west overlooking the northeast area.

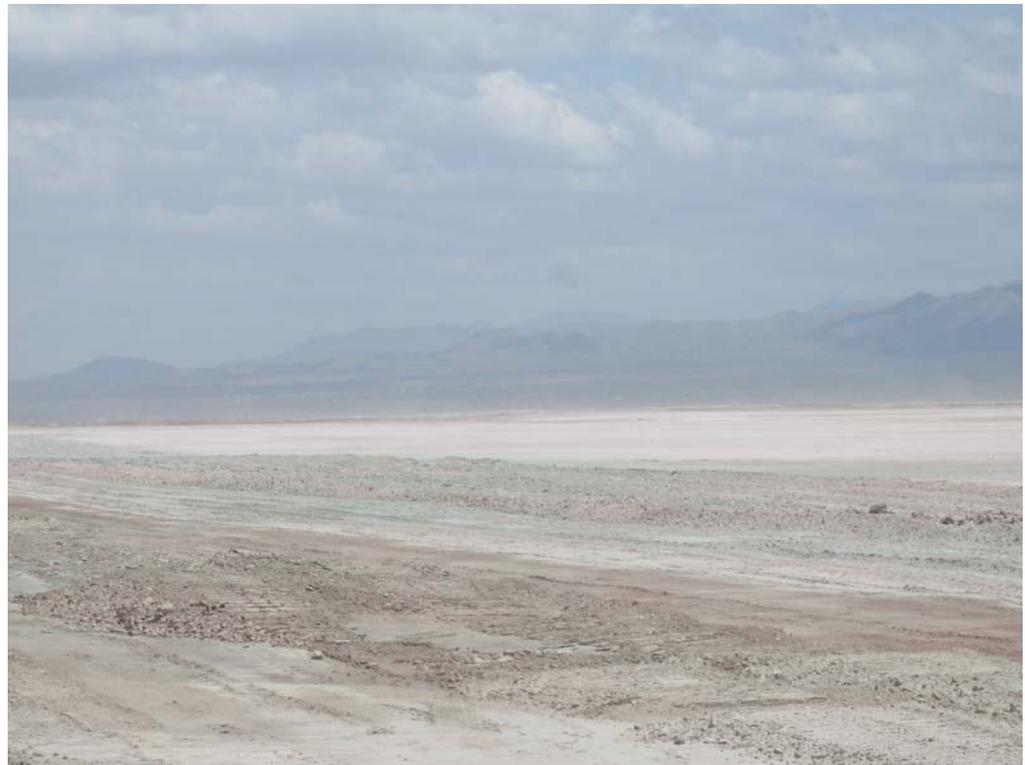
Photo No. 6

View of the dry surface area towards the interior of the northeast area of tailings dam #4 in the background.

The area in the foreground is the approximately 200' wide area where equipment has disturbed the outer edge of the tailings surface.

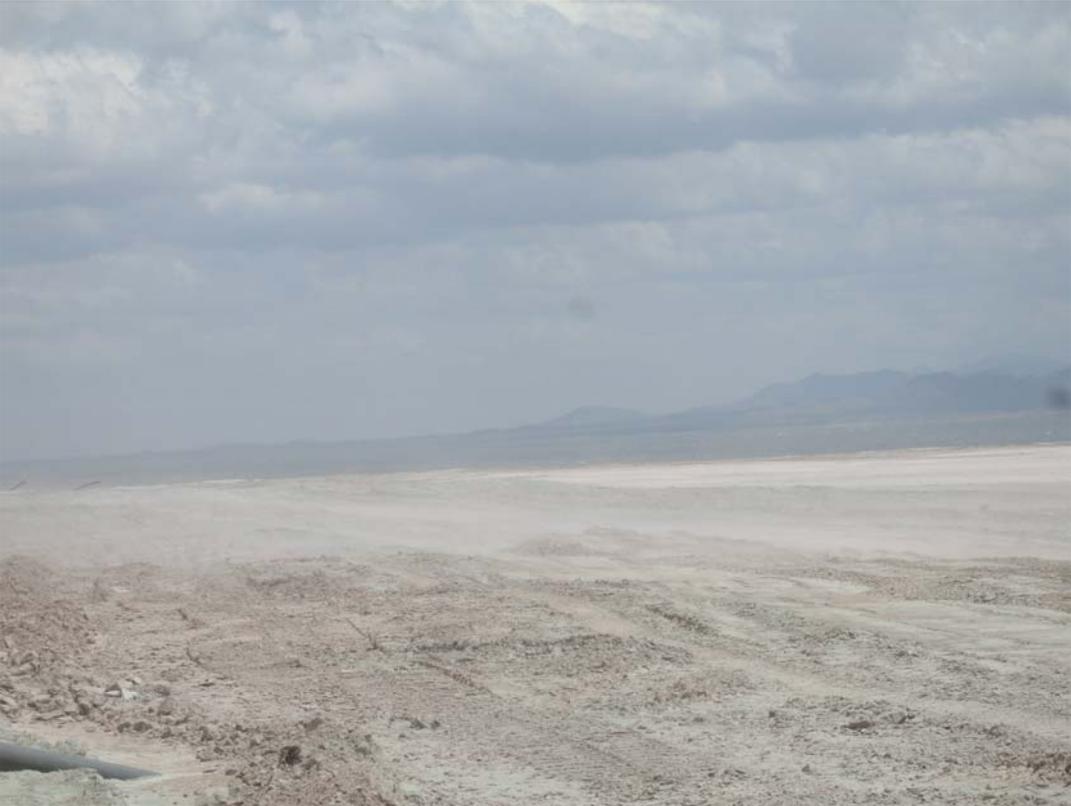
<p>Photo No. 7</p>

<p>Date: 04-21-2010</p>	
<p>Photo Description:</p> <p>A particulate emission plume generated from the surface of the dam. Taken prior to Method 9 VE observations.</p> <p>Time: 1:10 pm</p>	
<p>Photo No. 8</p>

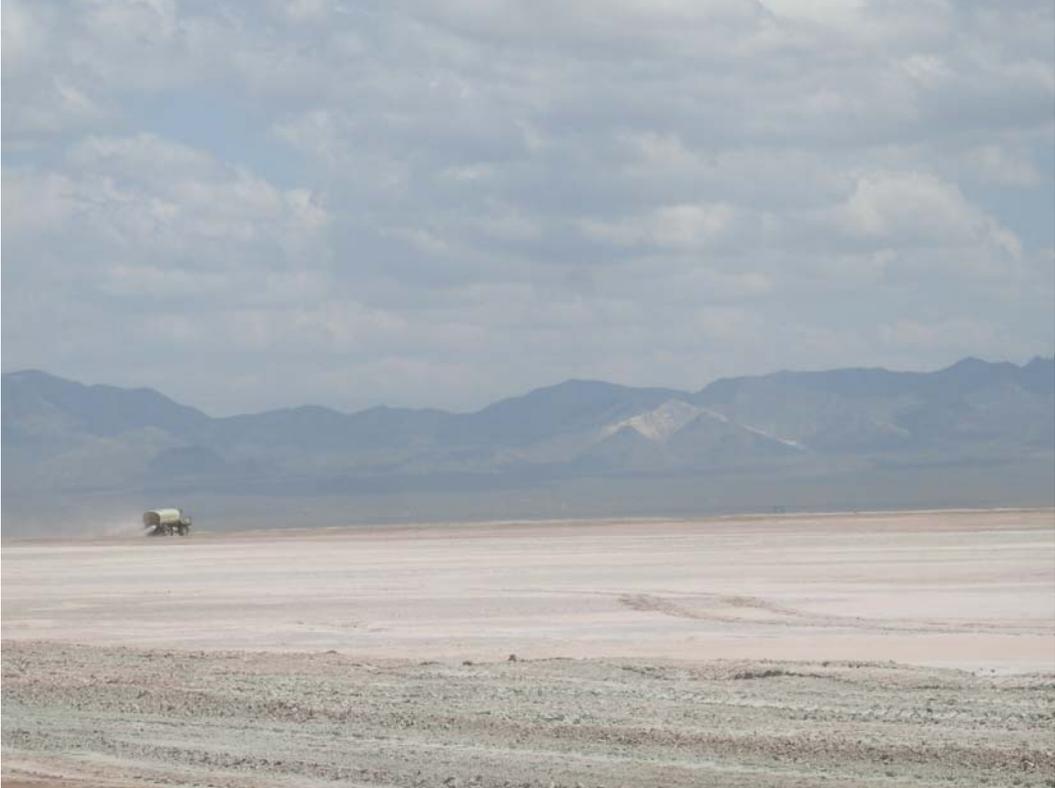
<p>Date: 04-21-2010</p>	
<p>Photo Description:</p> <p>View of water truck applying suppressant to the outer area of the dam.</p>

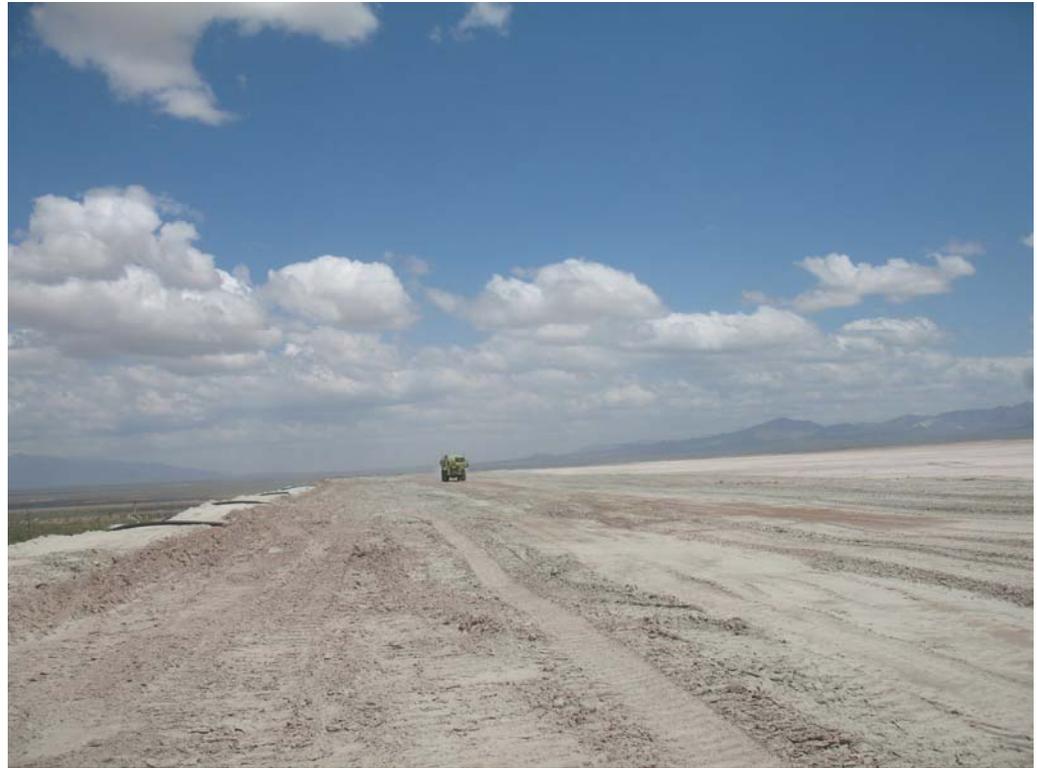
Photo No. 9

View of a water truck on the outer area of the dam.
